RE: Post-Closure Operation and Maintenance Report
November 2008 through October 2009
Operable Unit 2 (OU-2) Landfill Site
Former Lowry Air Force Base
Denver, Colorado

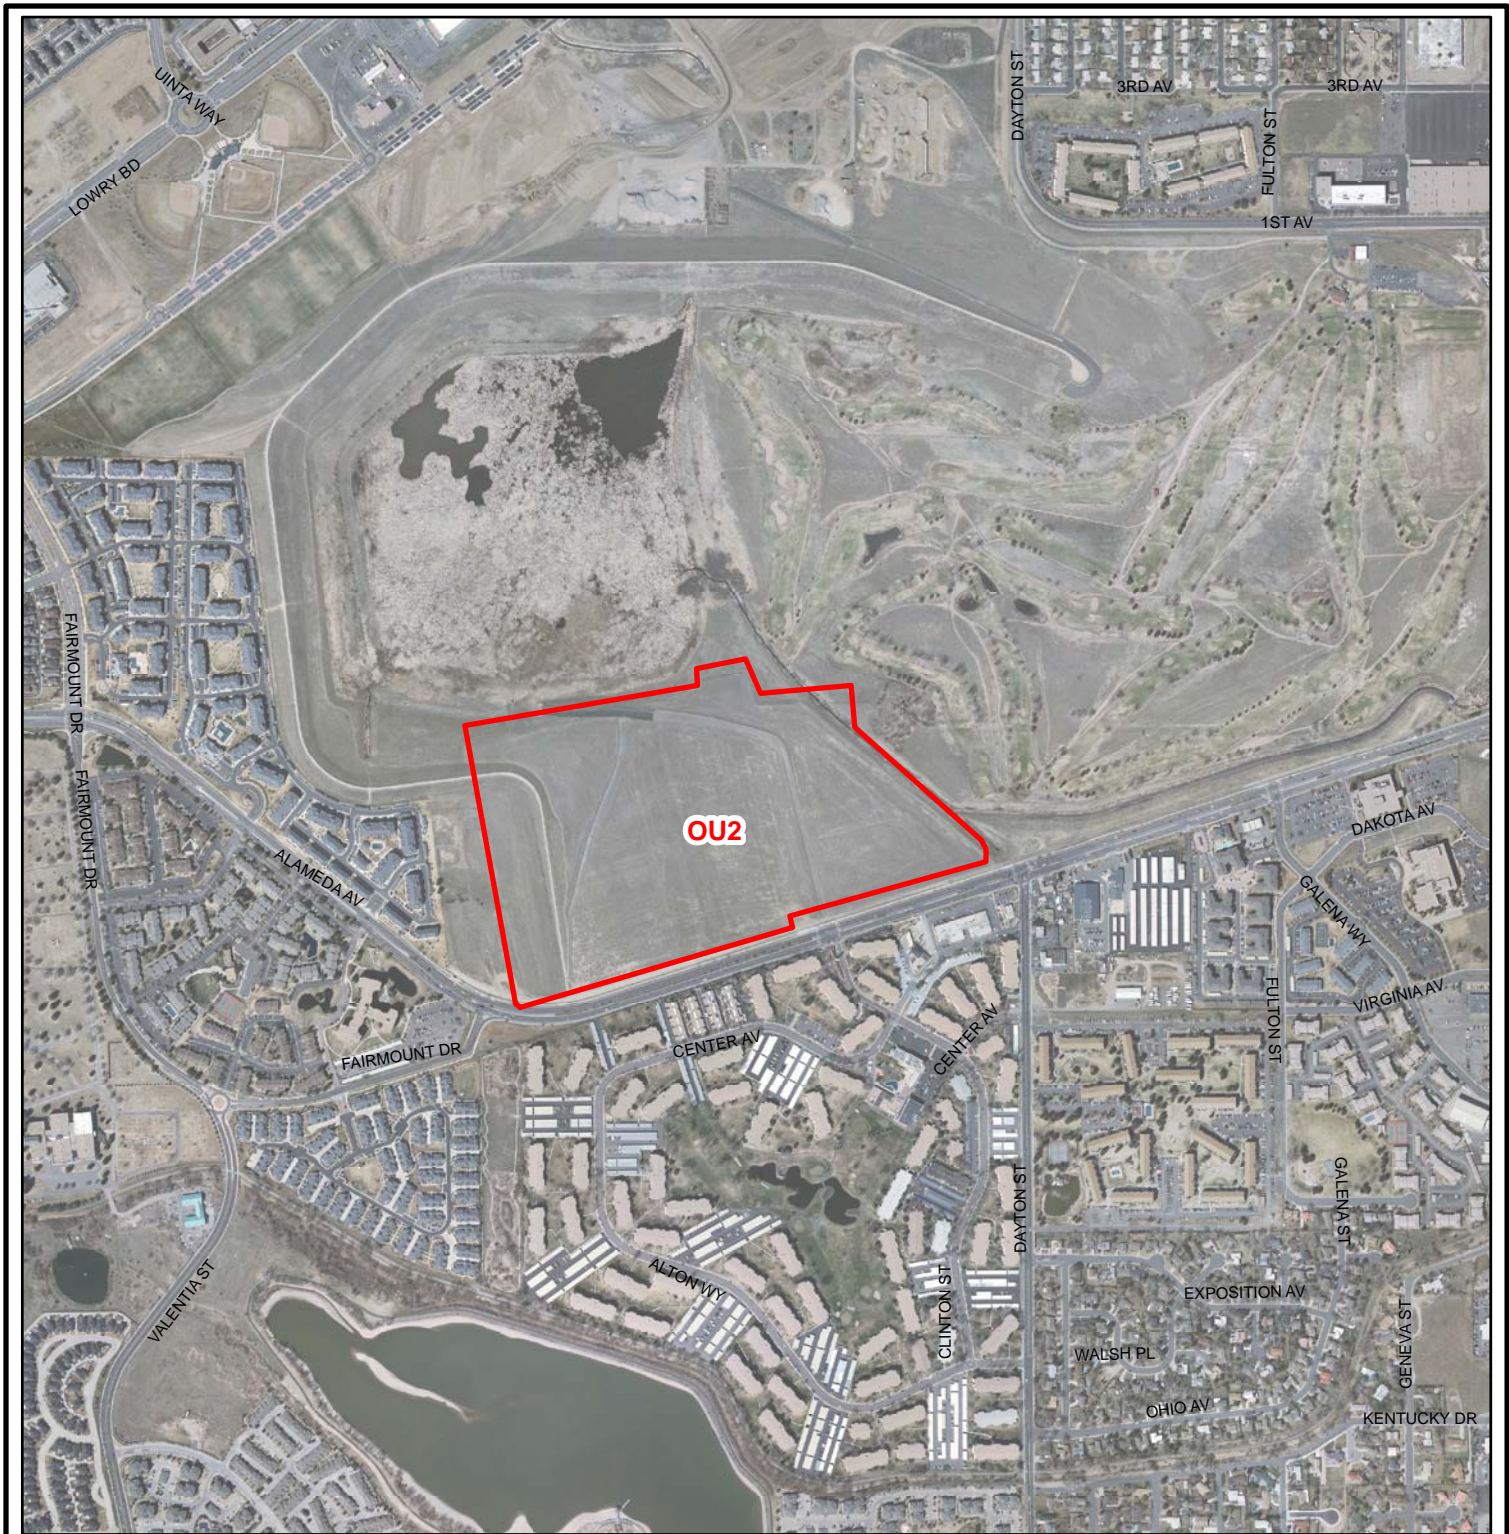
FIGURE 1
AERIAL SITE PHOTOGRAPH
LOWRY OU2 LANDFILL SITE
DENVER, COLORADO

IMAGE SOURCE: DENVER REGION AERIAL PHOTOGRAPHY PROJECT 2006

LT Environmental, Inc. (LTE) has been retained by Lowry Assumption, LLC (LAC) to conduct post-closure operation and maintenance monitoring at the above-referenced site (Figure 1). In accordance with the requirements set forth in the Colorado Department of Public Health and Environment (CDPHE) approved *Phase 2 Corrective Action Plan for the Operable Unit 2 Landfill Closure at Lowry (MACTEC, 2004) (Phase 2 CAP)*, LTE conducted the Operable Unit (OU)-2 post-closure operation and maintenance activities from November 2008 through October 2009; the third year of post-closure. During this period, LTE performed four quarterly monitoring inspections of the landfill cap, the surface conveyance structure, and the soil vents and gas probes. Site inspections occurred on January 21, 2009, April 24, 2009, July 28, 2009, and October 23, 2009. An additional monitoring inspection was conducted on March 11, 2009 to examine conditions resulting from a grass fire that occurred on March 8, 2009. Photographs and cap monitoring and maintenance activity reports are included as Attachments 1 and 2, respectively.
